Historic District Review Committee

Staff Report Addendum May 17, 2010

CAPP 2010-0002 Madison: New Residential Construction in the Waterford Historic District: PIN: 304-46-4671.

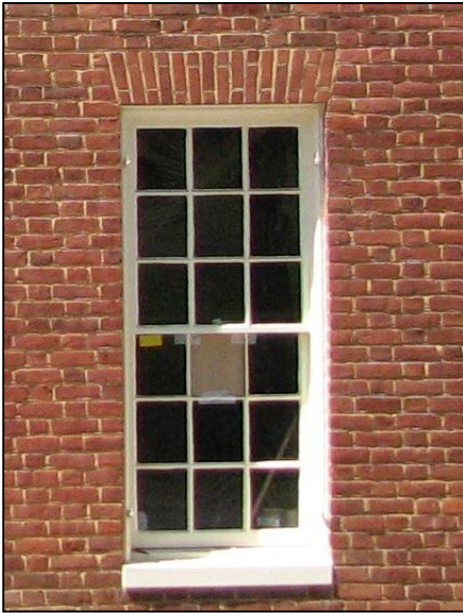
Photo 1: Typical brick jack arch on the Mahlon Schooley House on Second Street in the Waterford Historic District.

The applicant proposes flat jack arches above the windows constructed of a symmetrical row of vertical stretchers. This construction method does not follow historic precedent. Traditionally, jack arches have a trapezoidal shape created by cutting bricks to the correct shapes and sizes and have a height that is more than one stretcher length as shown in Photos 1 and 2 (Waterford Guidelines, Guidelines for New Construction: Materials and Textures, Text and Guideline 6, p. 75; Architectural Details and Decoration, Text and Guidelines 1 and 2, p. 73). **Jack arches that follow traditional building methods (trapezoidal shape, > one stretcher height, use of cut bricks) would meet the Guidelines.**

12. All windows in the main brick block will have flat trapezoidal jack arches across the top *constructed following traditional building techniques similar to photos 1 and 2 on page 2 in the Staff Report Addendum dated May 17, 2010. Attic windows in the brick main block will have a flat arch constructed of vertical header bricks.*

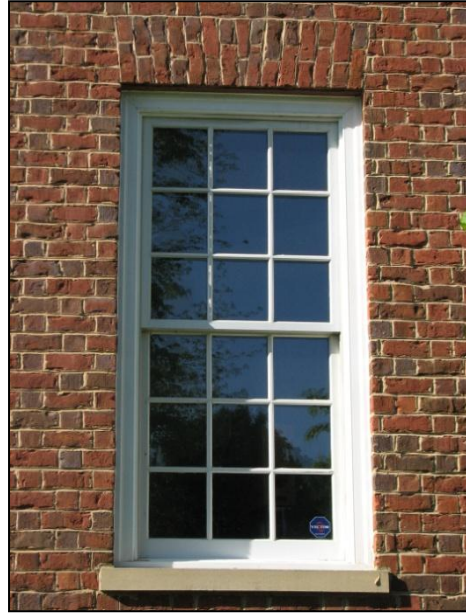
Photo 2: Brick jack arch on the Dunne Residence, 40171 Janney Street, indicating appropriate details on new construction in the Waterford Historic District.

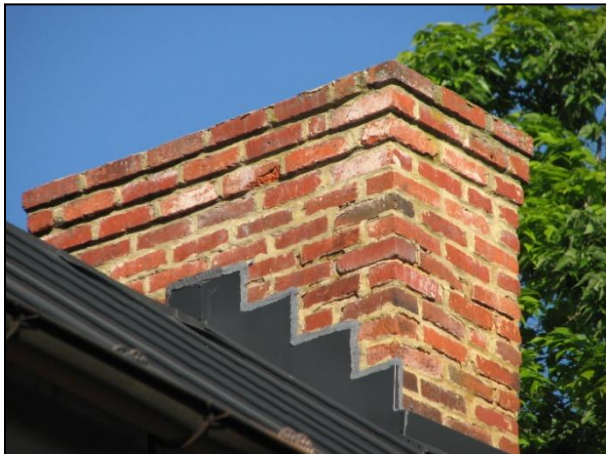
Photo 3: Example of simple corbelling on a historic chimney in Waterford.

buildings, as well as others found in the Waterford Historic District. New chimneys should be sympathetic to the design of those found on adjacent historic buildings (*Waterford Guidelines, Guidelines for New Construction: Chimneys, Guideline 4, p. 64*). Traditionally, chimneys in Waterford are finished with solid brick corbelling using full sized bricks, such as the chimney in Photo 3. **The chimney should have a simple corbelled top that follows traditional materials building methods to be in keeping with neighboring historic and non-historic residences and meet the Guidelines.**

3. The brick chimney must be constructed in running bond with a simple corbelled top to meet the Guidelines similar to Photo 3 on page 2 in the Staff Report Addendum dated May 17, 2010. The chimney brick and mortar should match the main block.

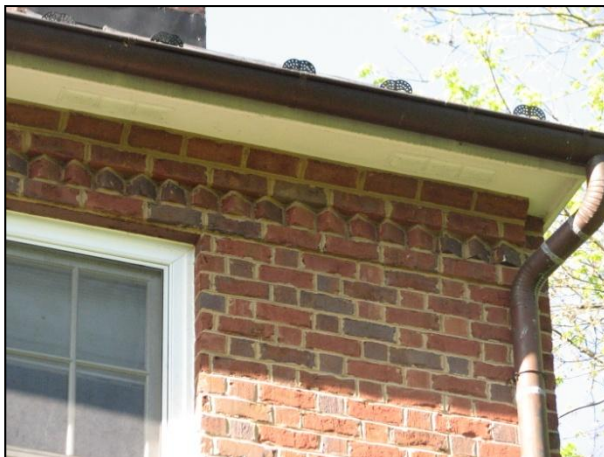
Photo 4: Brick corbelled cornice on the Dunne Residence. Also an example of rectangular vents in a boxed soffit.

While the boxed eave with a board soffit and very simple treatment at the roof-wall junction is appropriate for the cementitious sided wing, rear ell, and bump out (if necessary), **the brick main block should have a more classical entablature with a cornice and architrave based on the proposed building's formality and material to meet the Guidelines for Architectural Details and Decoration.** Variations of corbelled brick or variations of scotia cove or crown moulding applied to the boxed soffit are cornice types that are found on historic brick homes in Waterford. One of the cornices depicted below should be selected and replicated for the façade of the main block (Photos 4, 5, 6, and 7). The dimensions should match exactly. Materials should be similar, i.e. brick corbelling should be brick, wood cornice should be painted wood or painted VERSATEX.

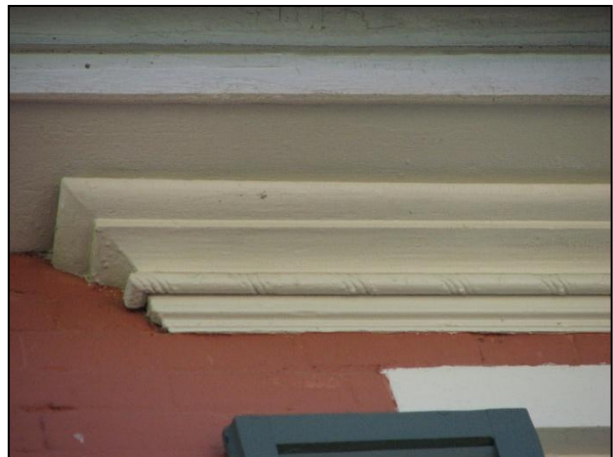
Photo 5: Moulded wood cornice beneath a boxed eave on the Pink House on Main Street in Waterford.

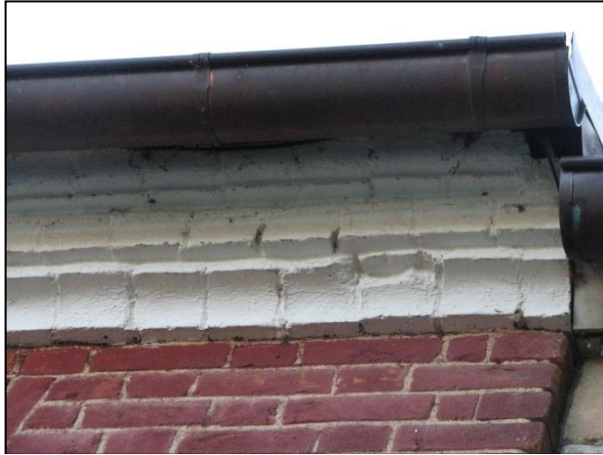
Photo 6: Brick cornice using scotia cove bricks on a historic brick house on Main Street in Waterford.

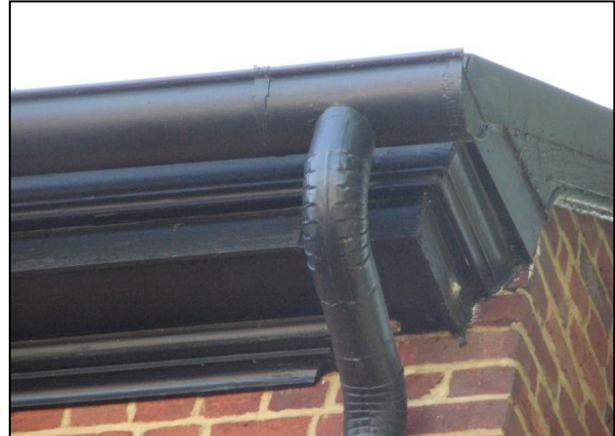
Photo 7: Moulded wood cornice with crown moulding applied to the boxed eave on a historic brick house on Second Street in Waterford.
